The Greenvale Nickel Mine

An Example of Innovative Mine Closure

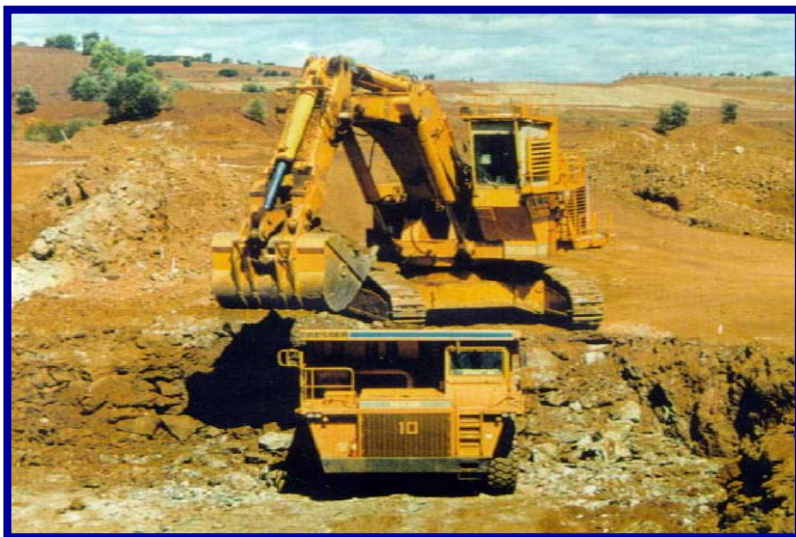
- Exposed ore drilled and blasted
- Draglines and excavators load broken ore to crusher and stockpile area
- Removal of overburden by conventional tractor/scrapper

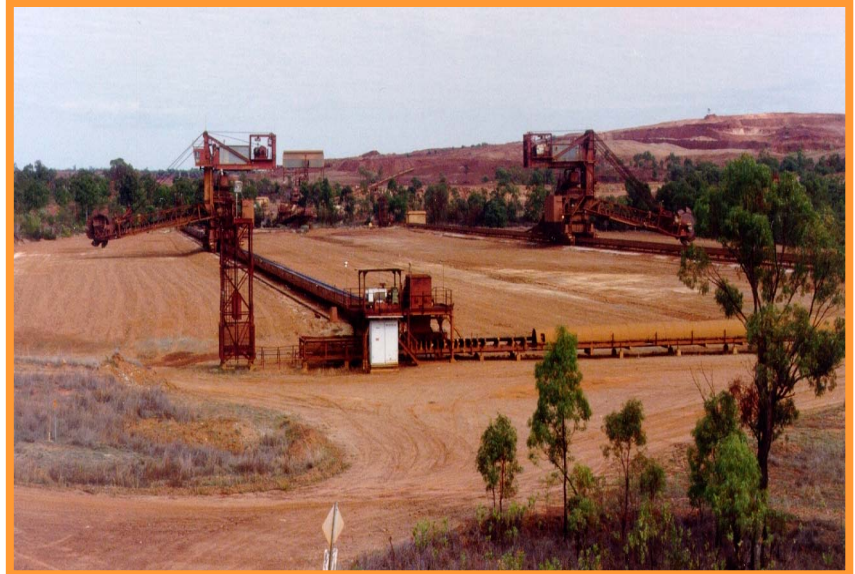
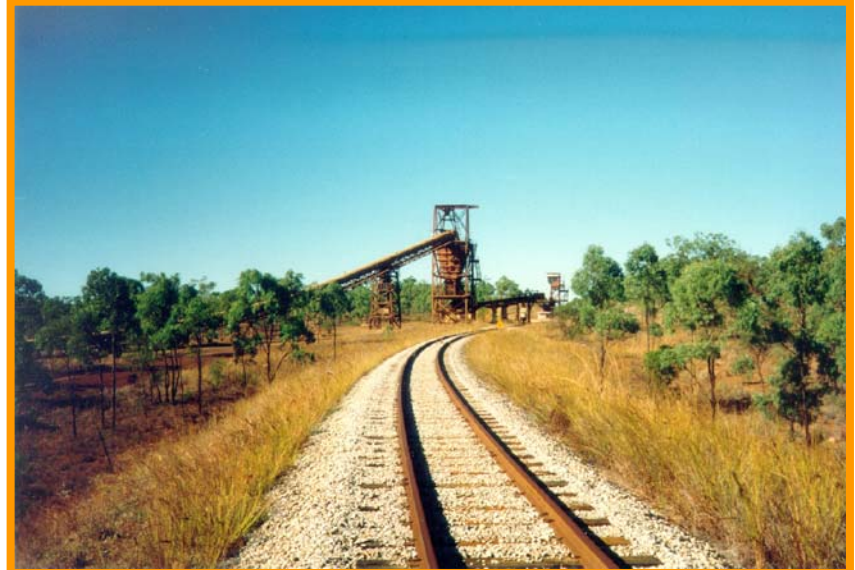
- Rejects to stockpile
- Bucket wheel stacker reclaimers loaded ore to rail cars
- Ore railed to Yabulu processing plant

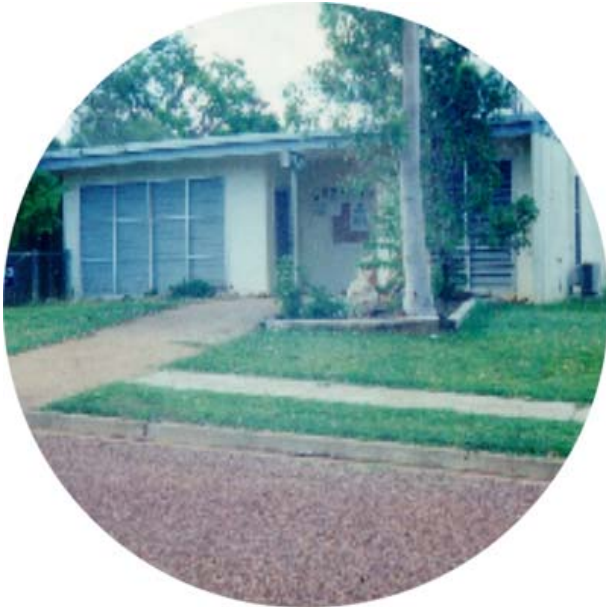
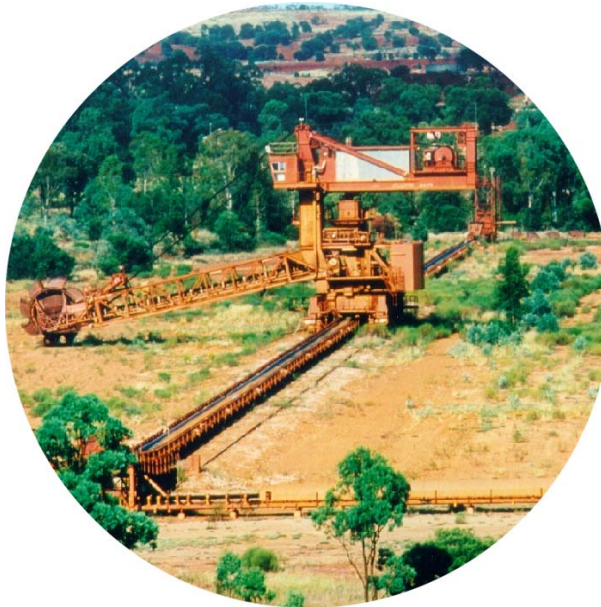
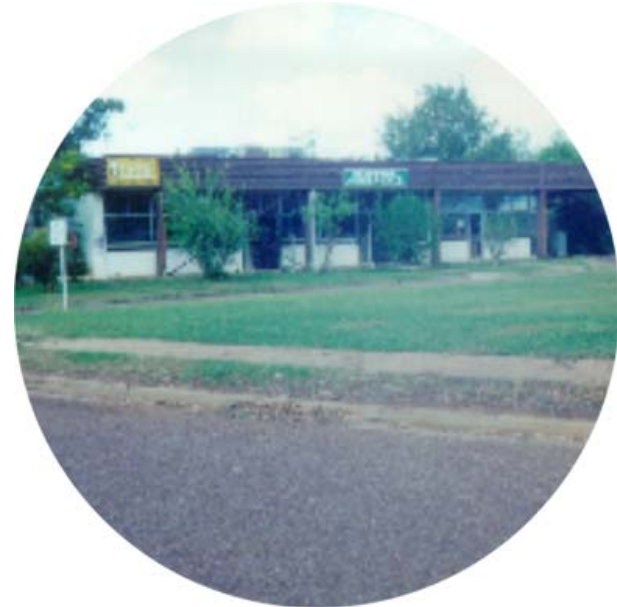
Significant Mine Infrastructure

- Crusher
- Switchyard
- Mine Office
- Ore Loaders
- Railway Line
- The Greenvale Township

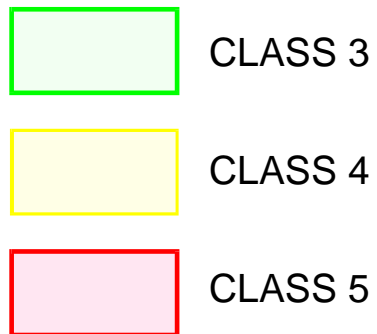
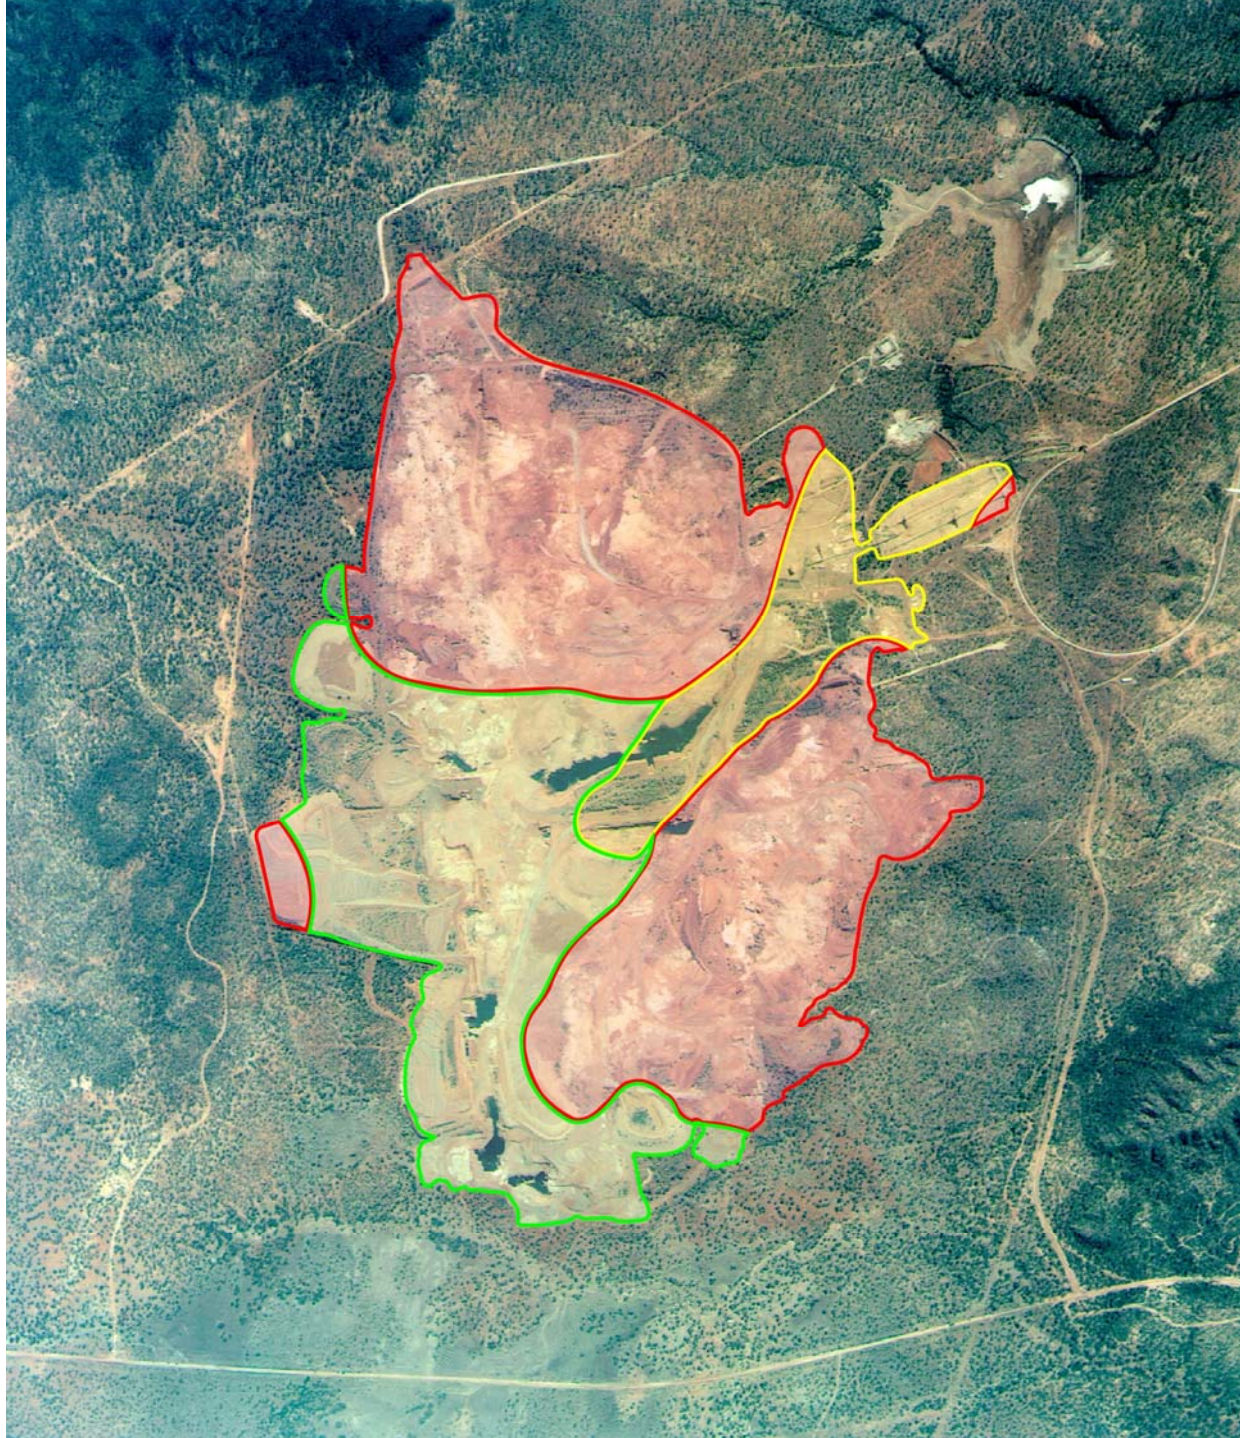
Target Land Suitability - Pre Mining

- Majority of site characterised by steep slopes, shallow soils, rock outcrops and dense Lancewood, which was considered to be unsuitable for grazing
- Major drainage lines dominated by red earths, native trees and grasses. Limitations on beef grazing use due to soil erodibility, surface condition, rockiness and rock outcrops
- Mid slopes and footslopes on structured red earths, suitable for grazing
- Variable colluvial/alluvial fans adjacent to major drainage lines suitable for grazing

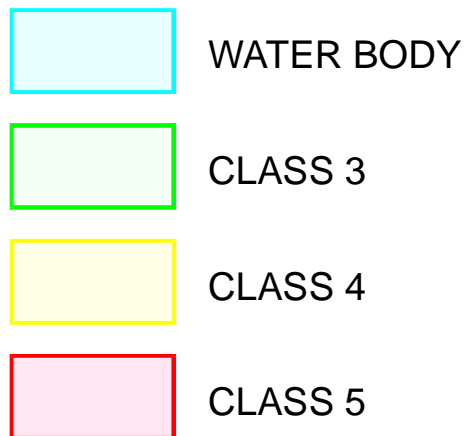
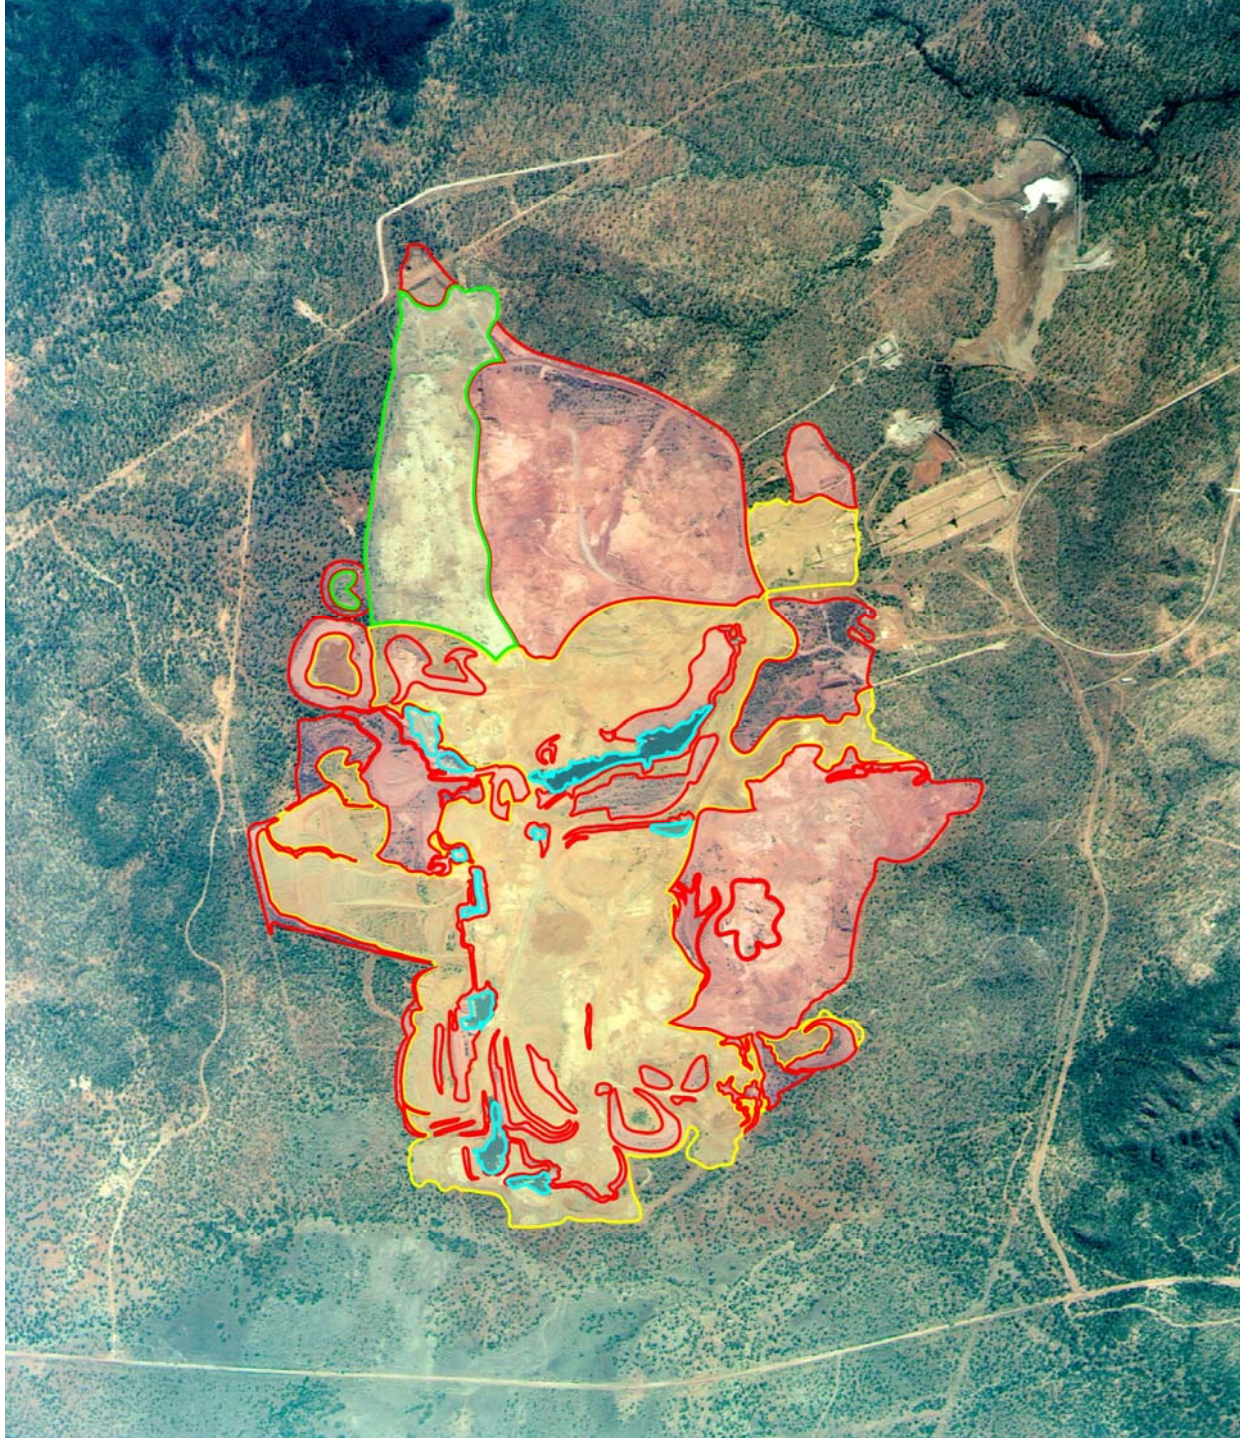
Target Land Suitability - Post Mining

Aim to provide at least the same quantity (and quality) of grazing land that was available prior to mining

To recognise that significant areas of the site were not suitable for grazing prior to mining

To provide stable landforms

To recognise the benefits of stock watering points in assessing available land use

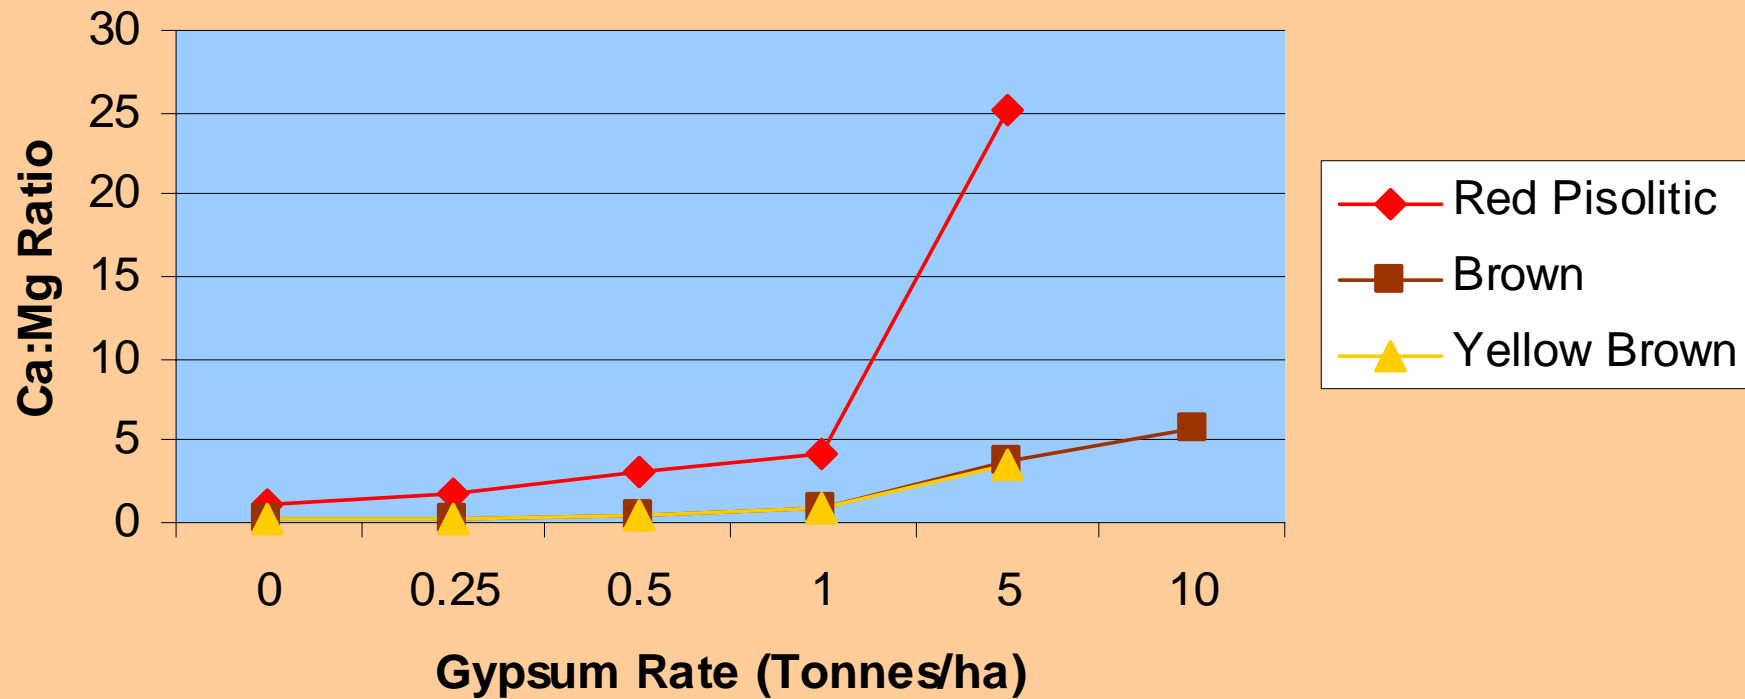
Gypsum Application Rate

- Related to both the low organic matter content and low calcium which result in a severe Ca:Mg imbalance
- $\text{Ca:Mg} < 2$ indicates potential structural problems
- Ca:Mg up to 5 is desirable for vegetation growth
- Trials to assess dosing rates of gypsum to ameliorate soils - up to 10 tonnes/ha

- 2.5 tonnes of gypsum per hectare
- 500kg/ha of fertiliser per hectare
- Blanket application rates to overcome variations in overburden characteristics across the site - also reduces the complexity of the operation

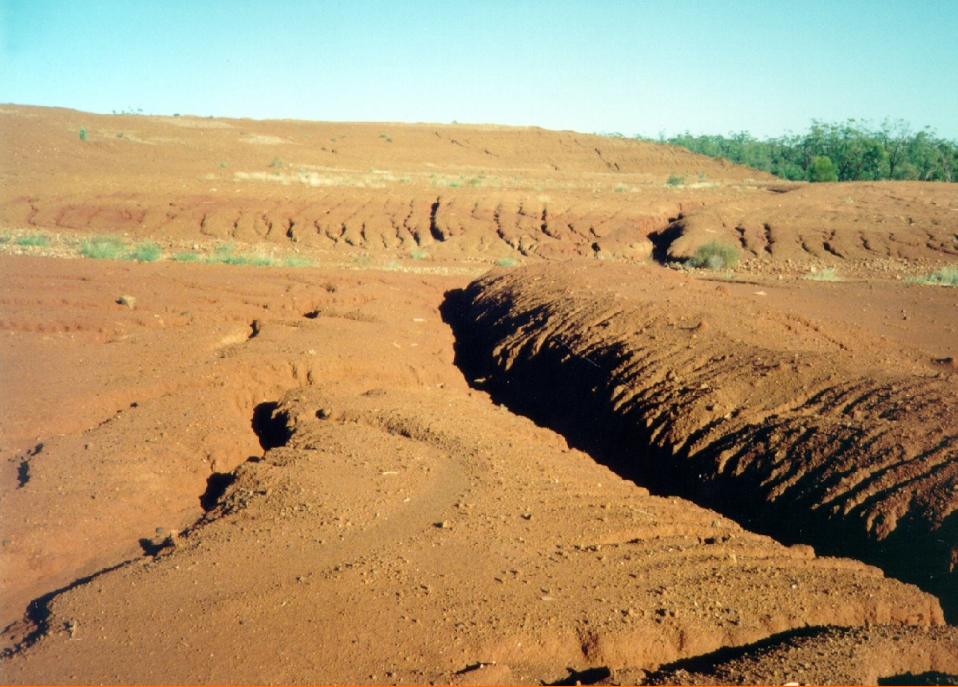
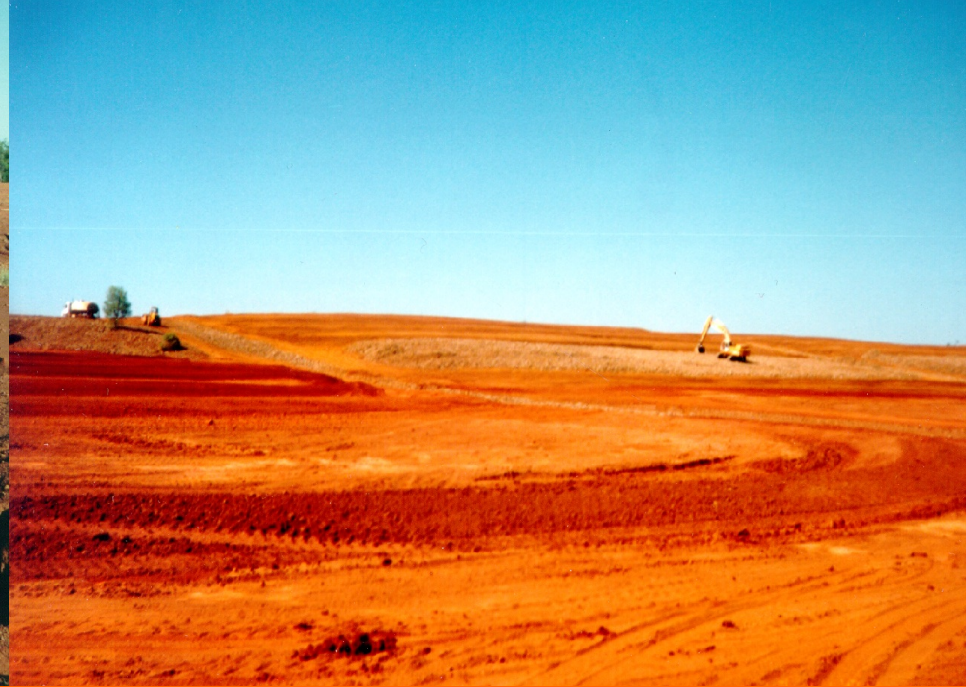
- **Reprofiling** of disturbed areas
- **Control of surface water** - target areas comprising fine, erodible soil, long slope lengths and history of erosion
- **Detention banks** - store water from small rainfall events to provide soil moisture for vegetation growth
- **Contour drains** - drains with limited fall to control erosion and divert water away from main slopes
- **Main drains** - rock lined drainage structures to collect and discharge water to drainage basins or water pits
- **Rock lining batters**

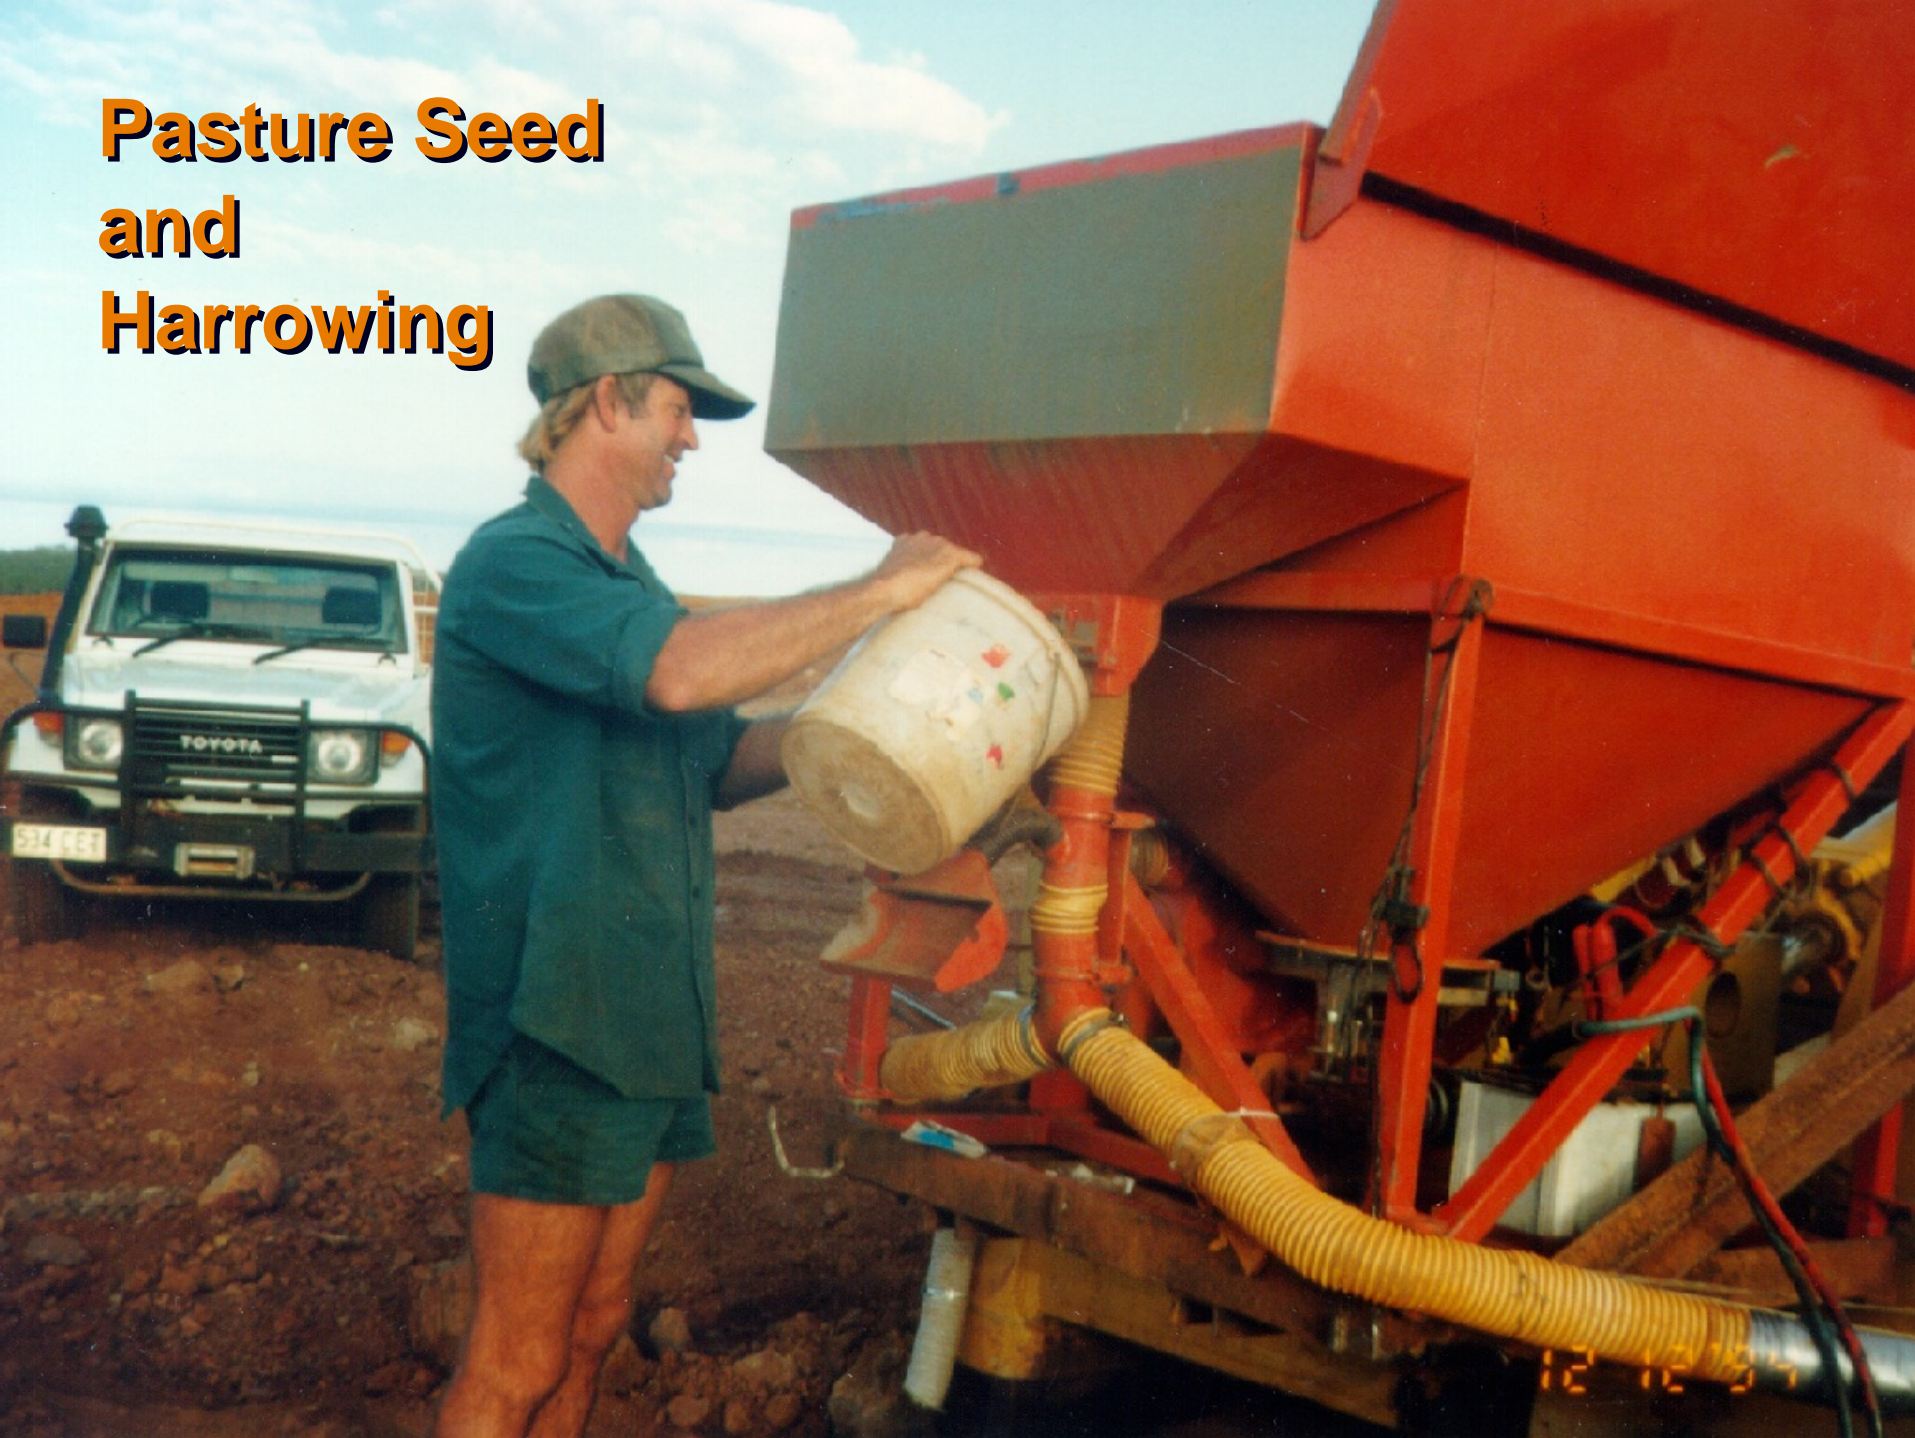
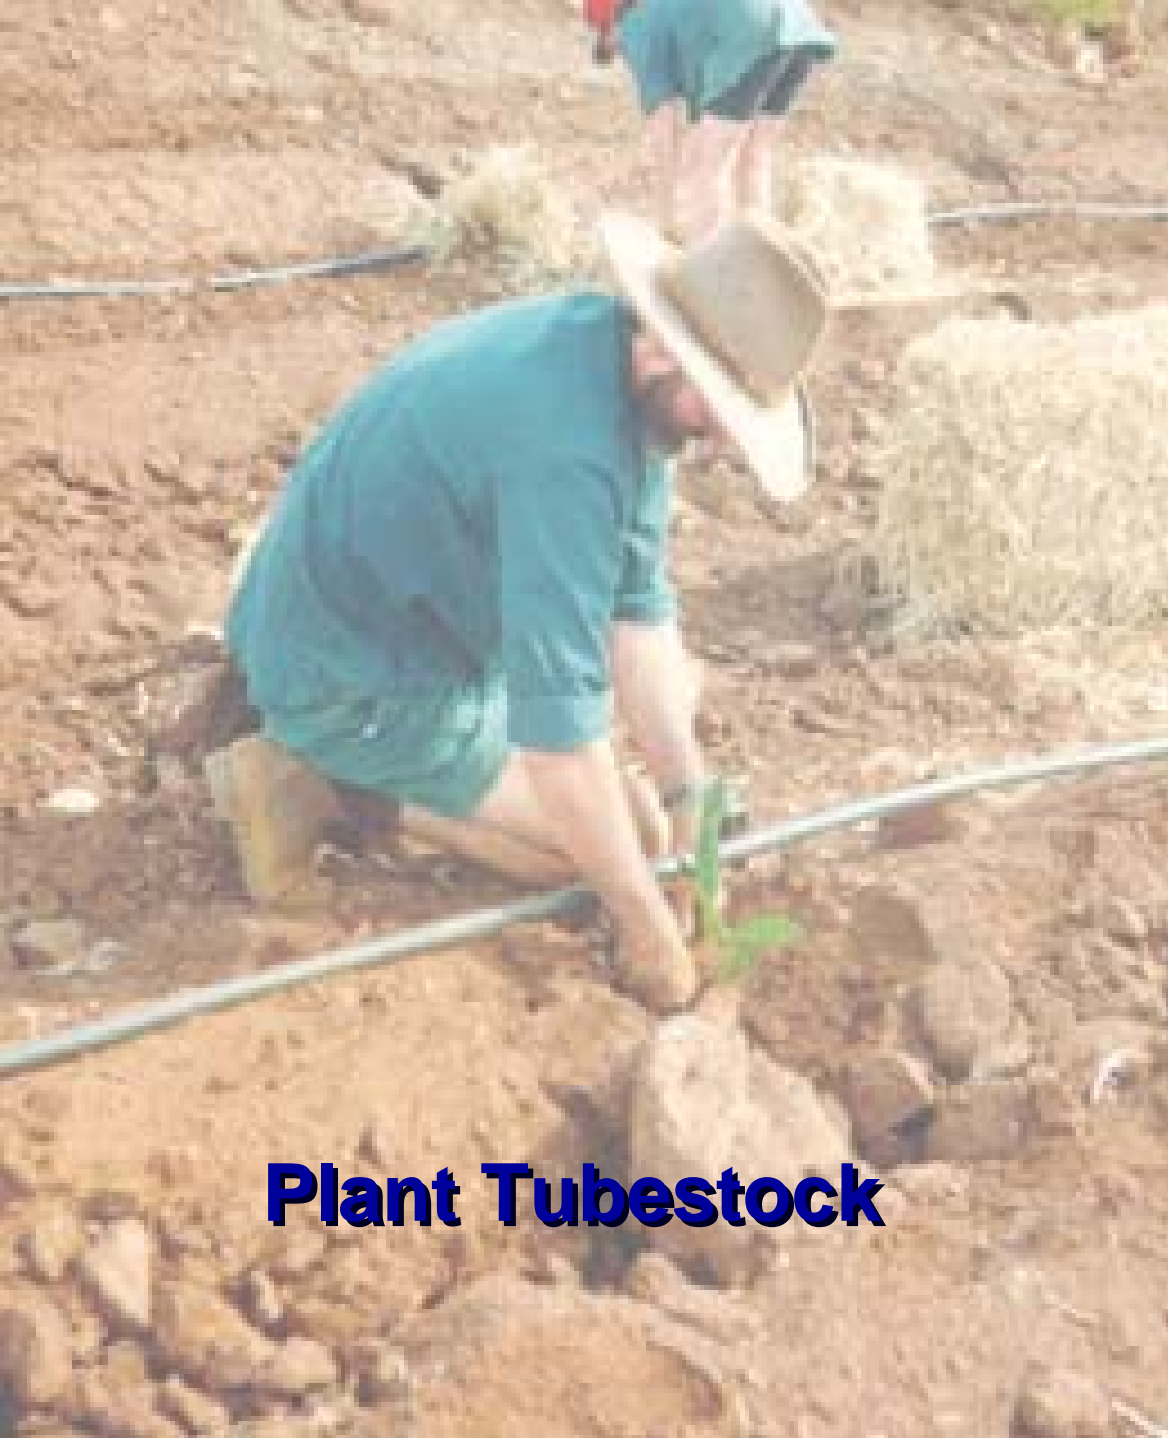
Pasture Seed and Harrowing

- Gypsum spreading - 2500kg/ha
- Deep ripping
- Fertiliser application - 500kg/ha
- Pasture seed - 40kg/ha
- Harrowing
- Hand broadcast native seed - 1.5kg/ha
- Plant tubestock - slow release fertiliser, straw and watering
- Native seed to rip lines - 4.0kg/ha
- Haymulch - 500bales/ha plus 2,000L/ha emulsion

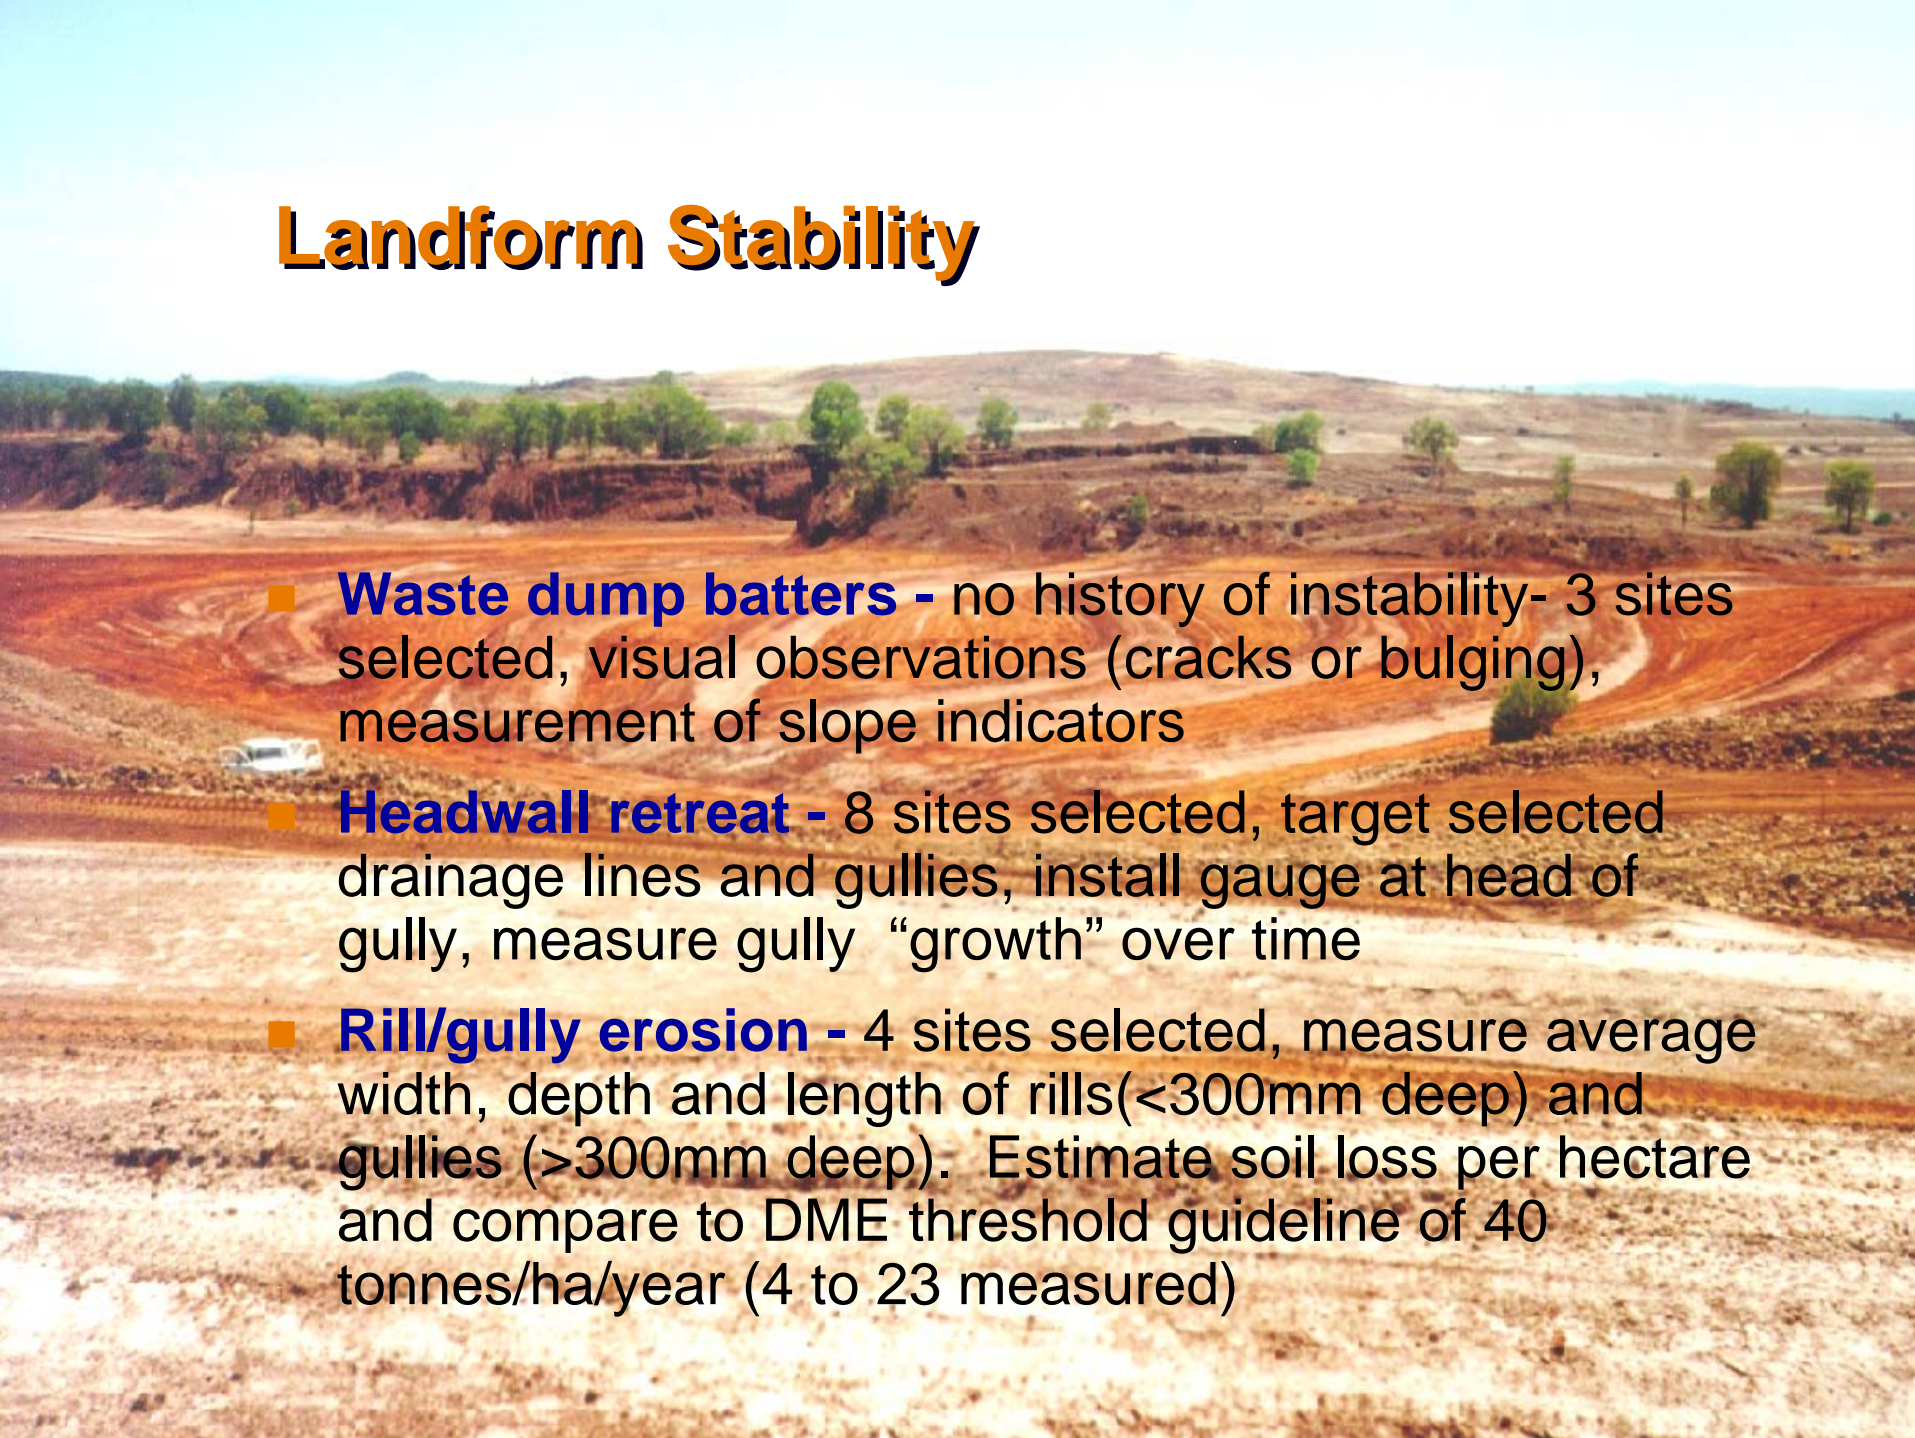
- **Waste dump batters** - no history of instability- 3 sites selected, visual observations (cracks or bulging), measurement of slope indicators
 - **Headwall retreat** - 8 sites selected, target selected drainage lines and gullies, install gauge at head of gully, measure gully “growth” over time
 - **Rill/gully erosion** - 4 sites selected, measure average width, depth and length of rills(<300mm deep) and gullies (>300mm deep). Estimate soil loss per hectare and compare to DME threshold guideline of 40 tonnes/ha/year (4 to 23 measured)

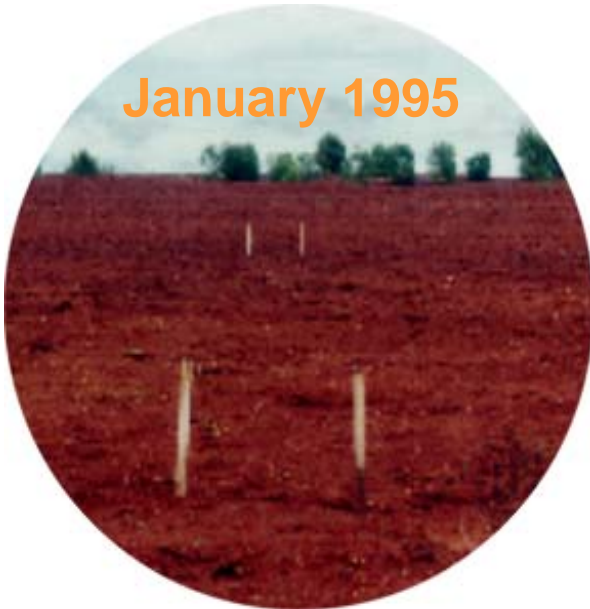
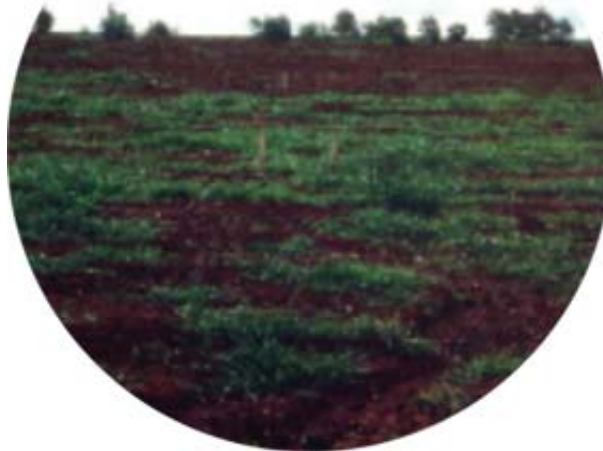
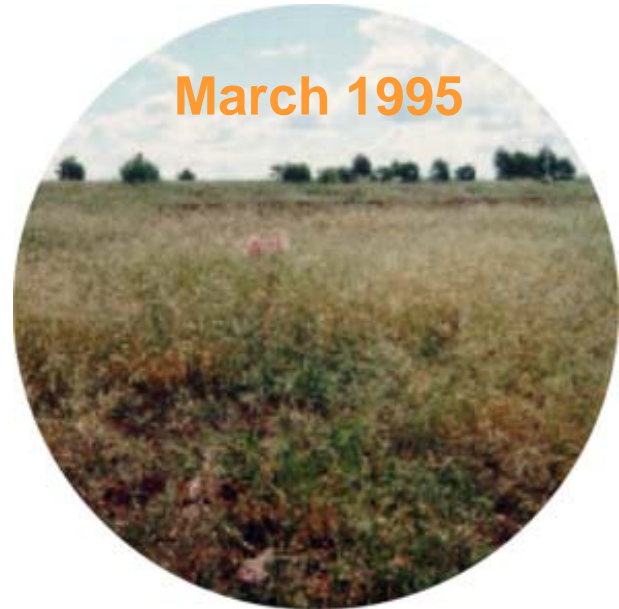
Monitoring Station 5

- Target vegetation cover for Class 3 and 4 of 85% of pasture cover at control sites
- Target vegetation cover for Class 4 and 5 of 85% of tree density cover at control sites
- All sites achieved or exceeded the criteria, some sites achieving a higher land suitability class
- Maintenance work identified across the site by comparing areas to monitoring sites
- Mapping of minor outbreaks of Calotrope or Parthenium - treatment during monitoring programme - no major outbreaks

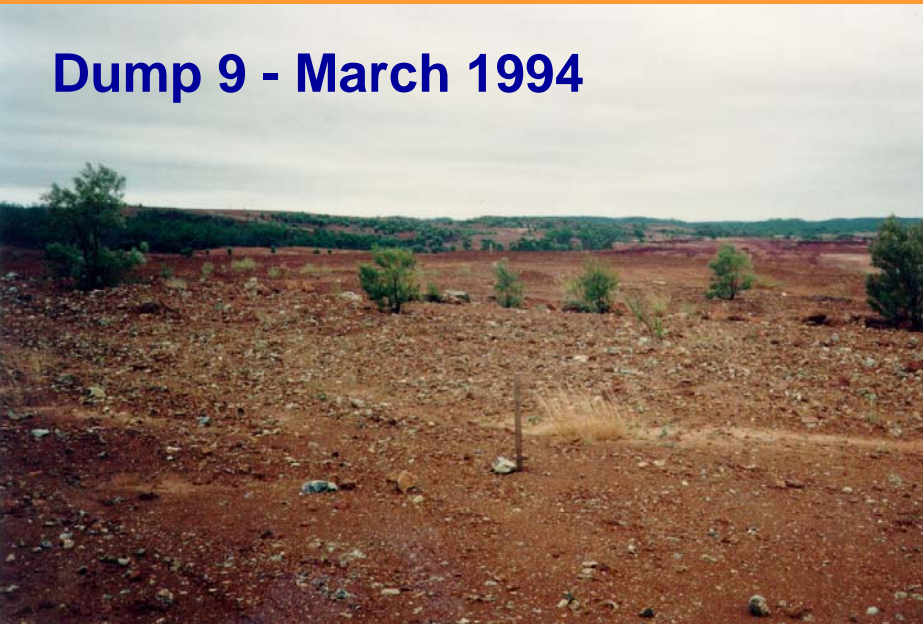
Dump 9 - March 1994

Greenvale - Successful Mine Rehabilitation
